**Report back on monitoring Married Persons Quarters sub-floor
and curtilage excavations (I44/316), Quarantine Island/Kamau Taurua
Recreation Reserve**

Shar Briden
19th April 2016
Revised 26th May 2016

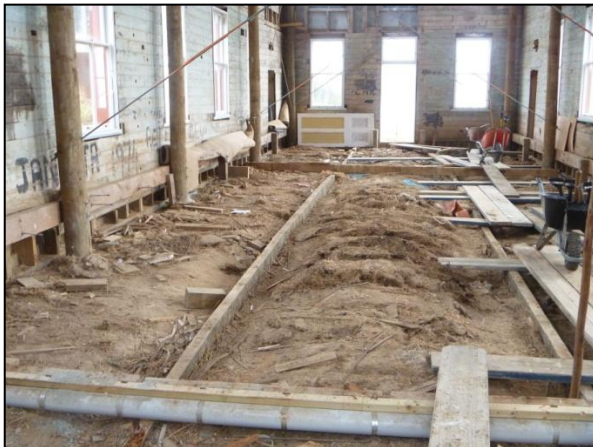
Plate 1. Sub-floor space 15th May 2015 after floorboards and joists lifted. View north.

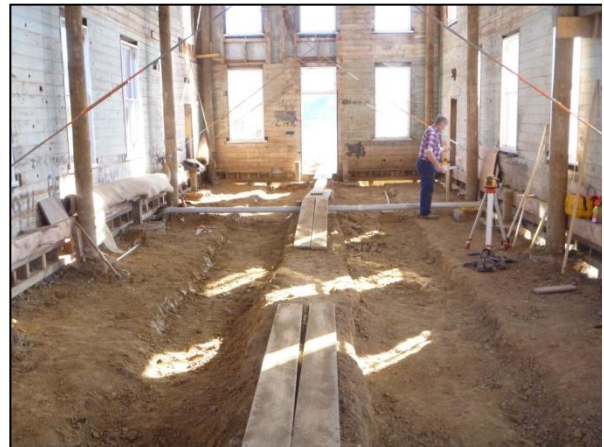
Plate 2. Sub-floor lowered for new bearers, joists and crawl space (12 June 2015).

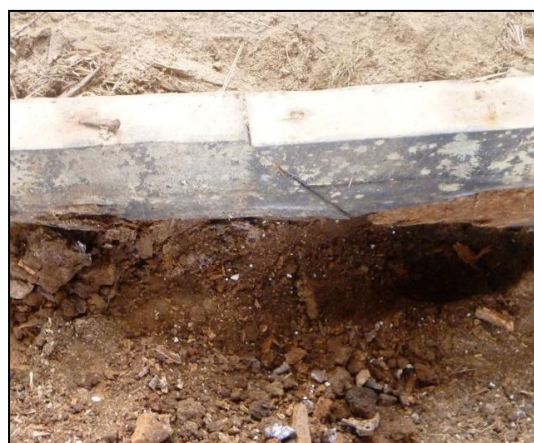
Plate 4. Bearer join and post hole at 7.8m north.

The bearers lifted measured 25 x 7.5cm. Hand wrought and cut nails were removed from the bearers as they were lifted. The west longitudinal bearer combined 2 lengths joined at 7.8m

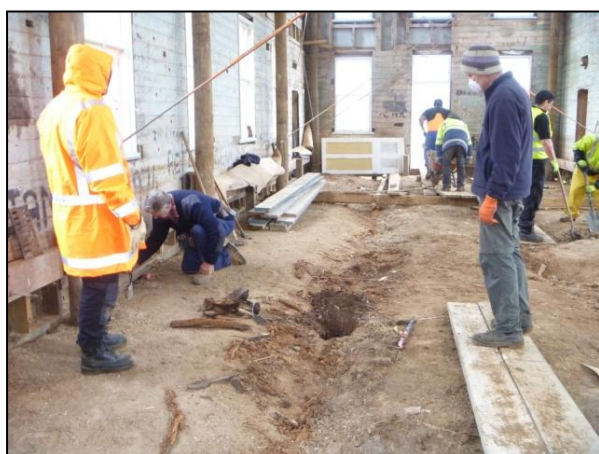
Plate 5. Post hole 5.4m north (west bearer) visible once bearer lifted.

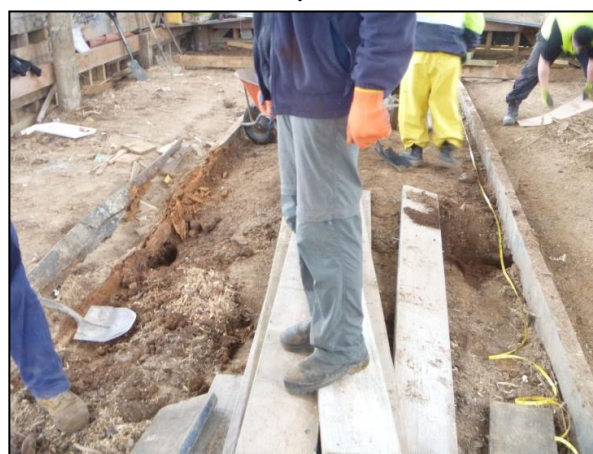
Plate 6. Two post holes at 7.8m north. View north.

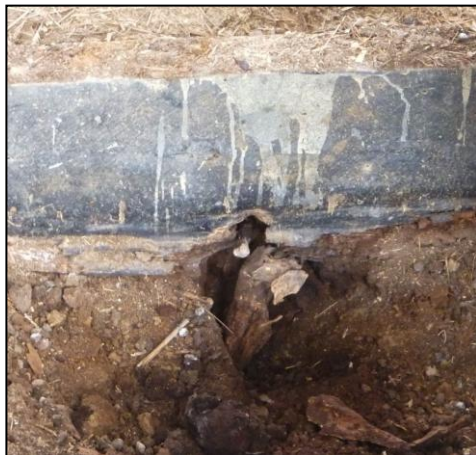
Plate 7. Remnant pile and cut nail beneath bearer 7.4m north Section E (item 20).

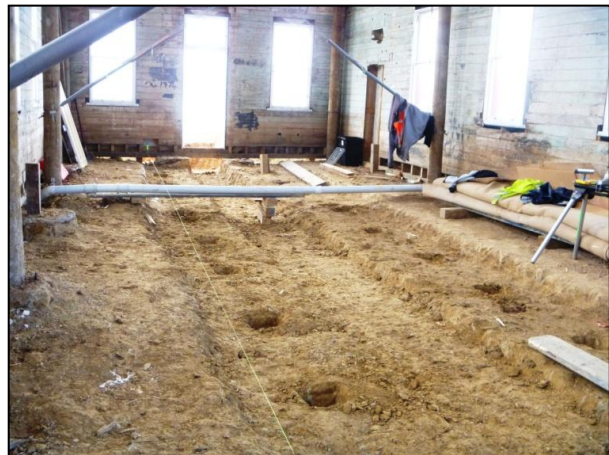
The wood piles measured 20cm square. Not all post holes were recorded only those evident while the archaeologist was on the island monitoring works. Plate 8 shows the new post holes dug for installation of new piles.

Plate 8. New post holes dug for new piles.

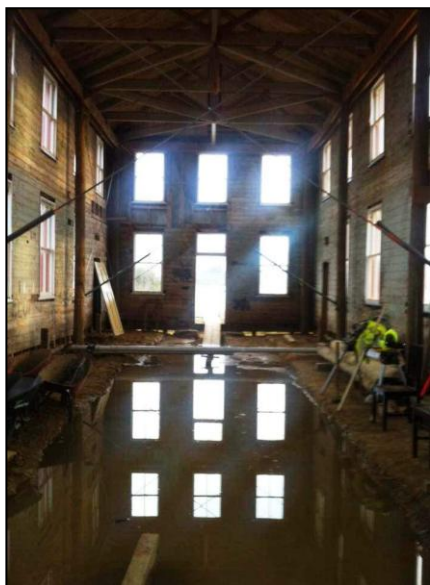
Plate 9. Flooded sub-floor space (MPQ) between 22nd May and 12th June 2015 (photo by Ana Terry).

The sub-floor area was completely flooded on and around 4th June 2015 (Plate 9). Don Hunter (caretaker of Quarantine Island) supplies the following information on the drains dug

The moat was breached during heavy rain hence the flooding of the MPQ sub-floor area. As an interim measure Don Hunter dug a temporary drain from the harbour side door of the MPQ down slope east towards the Chapel. The temporary drain has since been back filled. This drain digging was not monitored although Don and the work team collected all items and laid them aside for later recording. Plate 10 shows these items recovered during the work. The permanent drain runs from the south-west corner of the MPQ towards the North at a depth of around 0.8m – 1m.

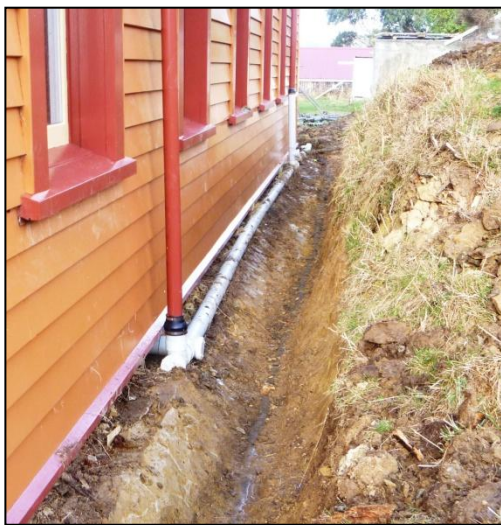
Plate 11. Drain coil in base of re-dug trench rear wall. View south.

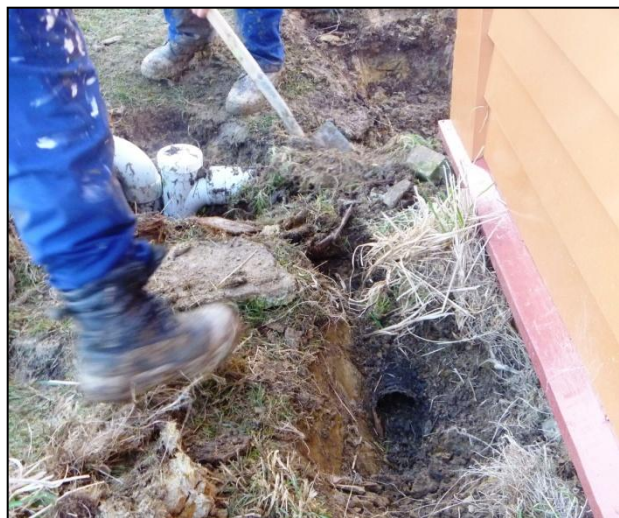
The west extent of the concrete path at the south-west corner of the building has been broken sometime during installation of the black drainage coil and PVC pipe (probably in 2010, Plate 12). The path was noted during monitoring of the drainage works in 2010 (Briden) 'A small section of the concrete path at the south-east corner (incorrect location in previous report as it is south-west) of the Married Person's Quarters will be removed and replaced following the laying of the roof water drain'.

Plate 12. Drain coil and PVC pipe south-west corner with broken concrete path. View west.

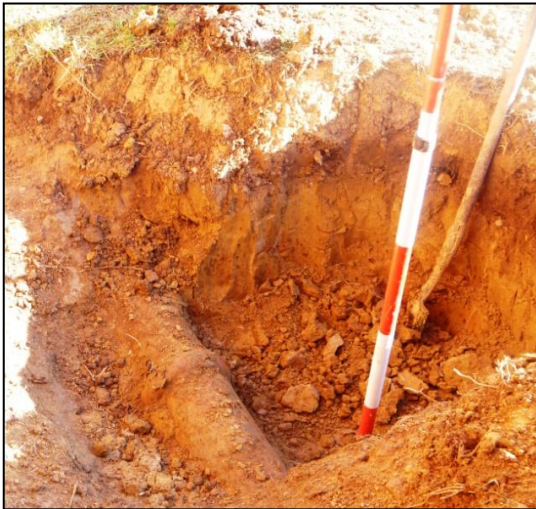
A larger hole was dug 0.8m wide and 0.78m deep on the north-east side of the building 12th June 2015 for a silt trap to be installed (Appendix 3). Clay drainage pipes were uncovered 0.68m out from the building wall that appeared to run the width of the building (although the full width was not uncovered). A smaller section of pipe (ca.12cm diameter) leads from beneath the building and joins with the larger pipe (ca.18cm diameter) 0.6m west of the buildings north doorway. The pipes lay at a base of 0.78mbs. Clay pipe fragments (previously broken) were lifted from this area. The pipe is glazed inside only. The smaller

Plate 13. Area dug for silt trap north side of building. Clay pipe became visible running alongside the buildings north wall. View west.

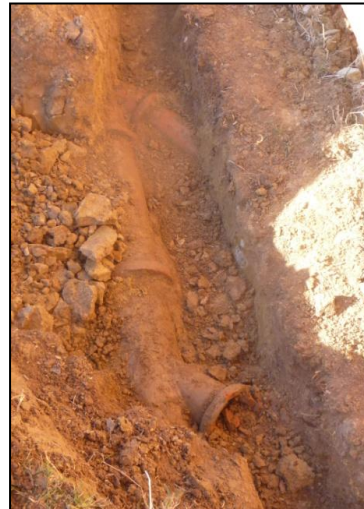
Plate 14. Clay pipes north side of building. View east.

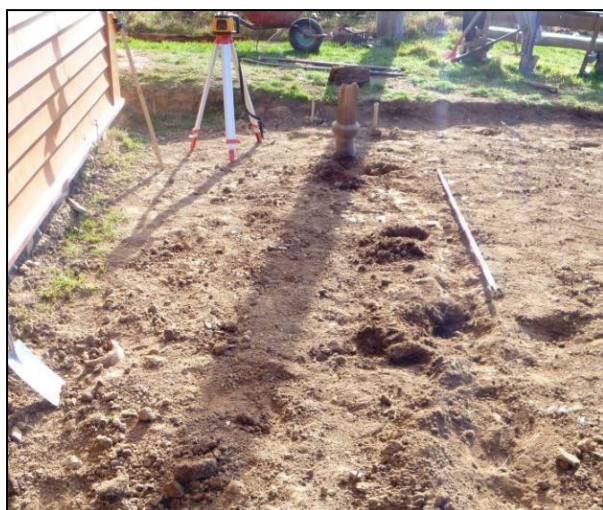
The remains of three wood piles supporting the lean-to were uncovered (centres measured 1.9m east from the building, Plate 16). The piles are 15cm square with pile holes dug to a depth of 17cmbs. The northern pile lay 1.07m south from the north-east corner of the building, the second 2.28m and the third 3.35m. The base timber plate lay north to south beside the wood piles 18cmbs and 2.2m east of the building. The timber extends 2m north to 3.35m from the north end of the building. The northern timber pile can be seen once it was removed (to right in Plate 10, pile left on site).

Half a large clay pipe (A) 20cm in diameter was recorded standing upright 0.5m east from the building and 3.58m south of the north-east corner of the building (Plate 16). The pipe is glazed inside only. A piece of timber lay 30cmbs located between the clay pipe and the building. A fragment of black plastic was also recorded. A broken drainage pipe lay 2m east out from the building and 1.6m from the corner (top at 35cmbs). This pipe angles downward and was not uncovered any further to ascertain its alignment down the slope.

Plate 16. Post holes of lean-to. Ranging pole (2m long) indicates location of remnant bearer. Half upright clay pipe beside spade to left. View north.

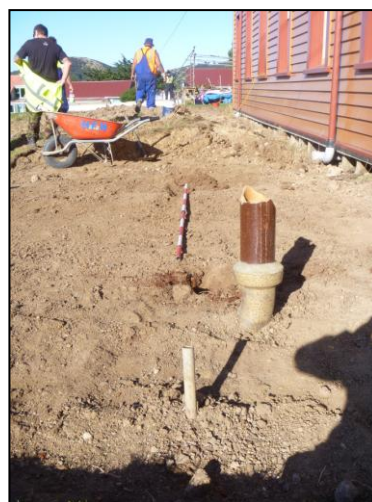
Plate 17. Upright lead pipe and clay pipe of lean-to. View south.

A clay drain pipe (B) 13cm diameter (external) stands upright 0.6m south of the MPQ north extent and 1.3m out from the building (Plate 17). The pipe is glazed outside only. This pipe probably relates to the toilet outlet. Lead piping sticks up out of the ground 1.8m east from the buildings north-east corner (in line with north wall). The lead pipe appears to have been a water pipe installed on the outside of the north-east corner of the lean-to that may be the water supply for the toilet.

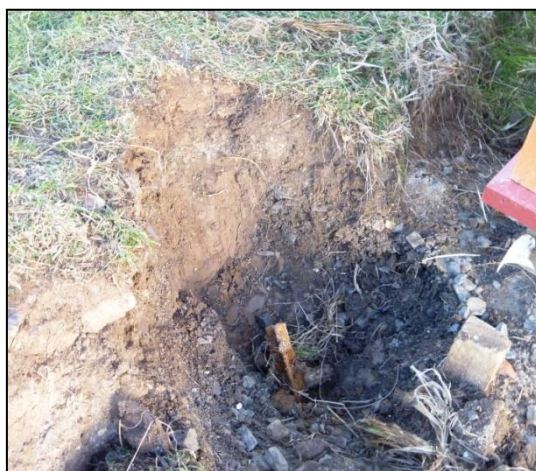
Plate 18. Spoil cleared from north-east corner of the terrace showing stratigraphy. South-east corner of the MPQ to right.

Plate 18 shows the sub-surface layers beneath the south-east corner of the MPQ (to right in photo). This location was a gap left between the dining room, the kitchen covered area, and the MPQ building (Otago Daily Times 16 June 1874).
